## CHAPTER 12

## Lessons Learnt from Habitat Restoration at Marsiling Park

Eslindah Ismail &amp; Cai Yixiong

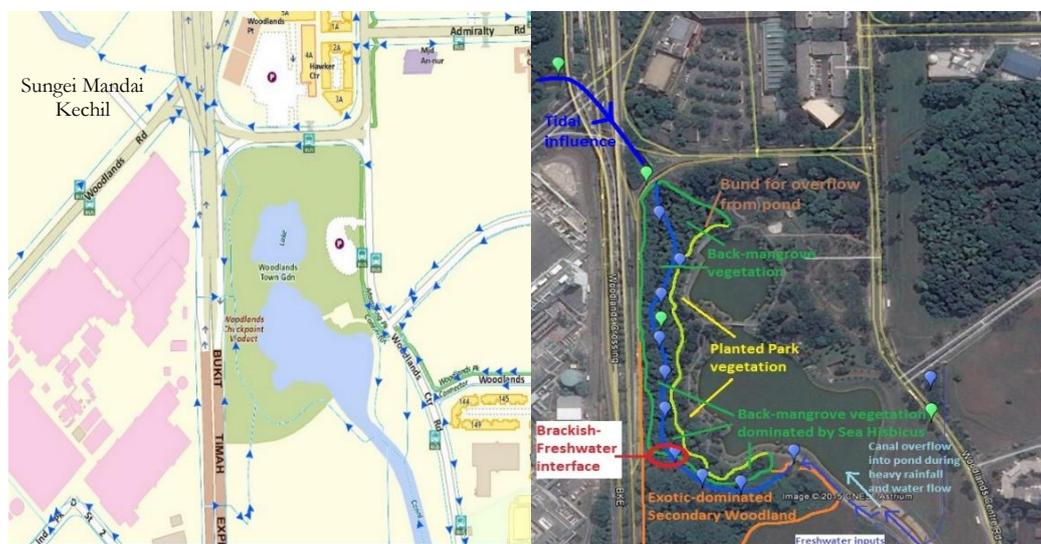
Figs. 2. Map of Marsiling Park showing the mangrove forest and its hydrological connections. (Image credit: Base map OneMap@2016; Base map Google Earth@2016, National Parks Board, 2016b)

The mangrove forest is a highly degraded remnant back mangrove (National Parks Board, 2006), with freshwater inputs entering it via the bund for overflow from the PUB storm water pond and lined drains (Fig. 2 & 3). It also includes the uppermost end of the upstream section of Sungei Mandai Kechil, thus it is inundated during high tide. The lower course reaches to Sungei Mandai Kechil and is surrounded by Sungei Mandai Mangrove. The substrate of the site is mainly composed of siliceous sand. Surrounding the back mangrove is grassland, secondary forest, and typical trees in the park (Fig. 4). The section that connects Marsiling Park and Sungei Mandai Mangrove has been turned into a concrete channel as a result of urbanisation (Fig. 5).

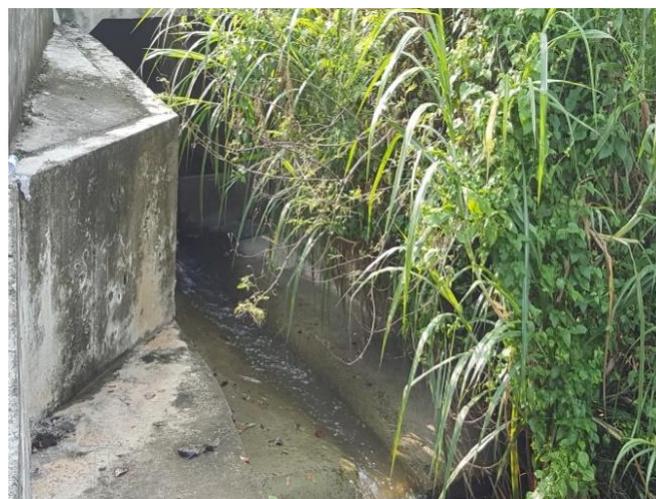
Fig. 3. Freshwater inputs entering the mangrove forest via the bund for overflow from the pond and lined drains.

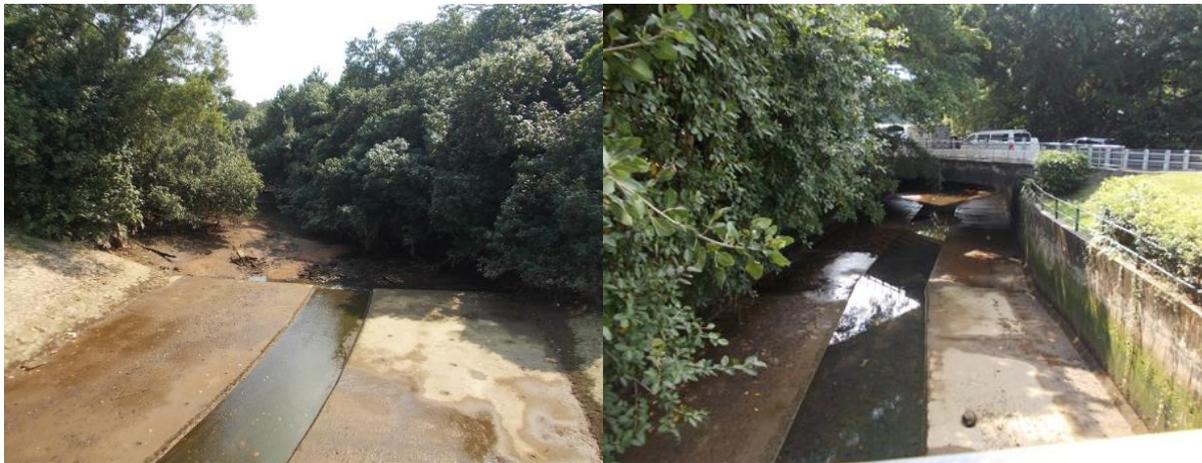
Figs. 5. Part of the Sungei Mandai mangrove that had been concretised into drains.

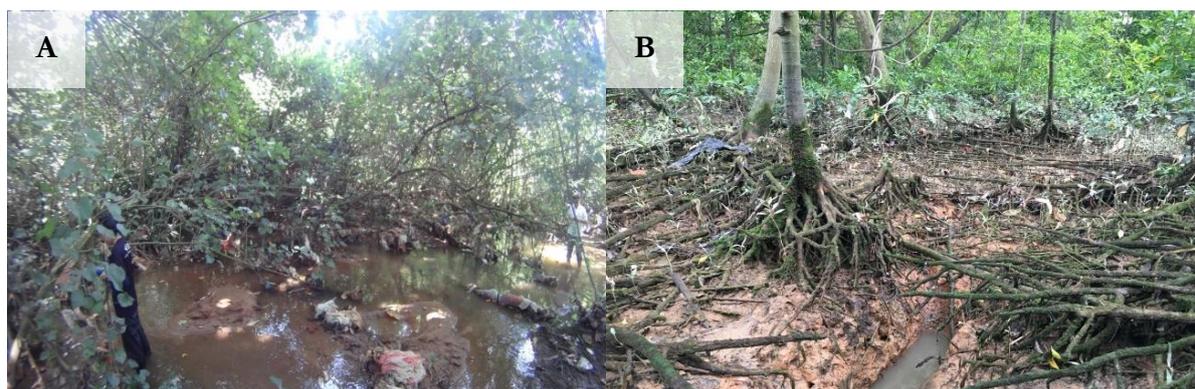
Figs. 6. (A) Flotsam in the mangrove area; (B) Soil erosion observed at the mangrove patch next to the PUB Storm Water Pond. (Photo credit: Cai Yixiong)

The mangrove forest faced threats such as the massive inflow of freshwater from the drains and storm water pond that was filled with flotsam during heavy rainfall (Fig. 6A), human disturbance like littering and poaching, and the canalisation of Sungei Mandai Kechil into concrete drains which reduced the inundation by seawater during high tides and thus altered the site's hydrology. This also caused the mangrove habitat to further degrade; the habitat could even disappear eventually in the long term due to the lack of saline water input, which lowered the salinity level of the water in the mangrove site, and could result in the loss of some key species of the flora and fauna. In addition, soil erosion and siltation had slowly built up along the mangrove course due to the changes in hydrology at site (Fig. 6B).

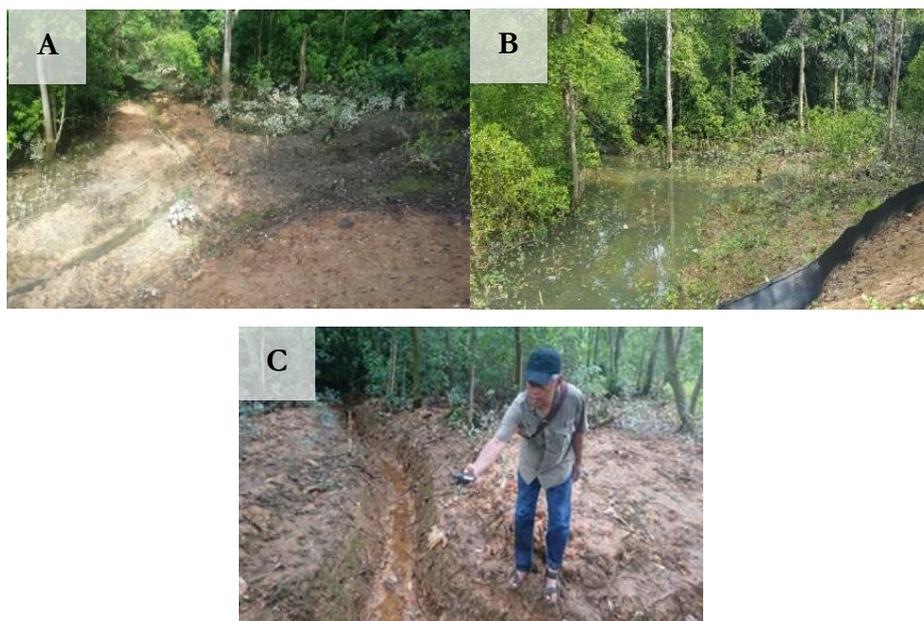
Figs. 7. (A) Excavated channels in mangrove; (B) Monitoring of tidal flow at the channels; (C) Mapping of the excavated channels.

In order to change the profile of hydrology, the impact of the tides at the site was studied. Channels were excavated and small islets were created in the channels to improve the water flow into the mangrove and mid transitional habitats (Fig. 7A). These channels were monitored to ensure that sea water would flow smoothly into them (Fig. 7B). They were then mapped using GPS technology for use in future studies of the site (Fig. 7C).

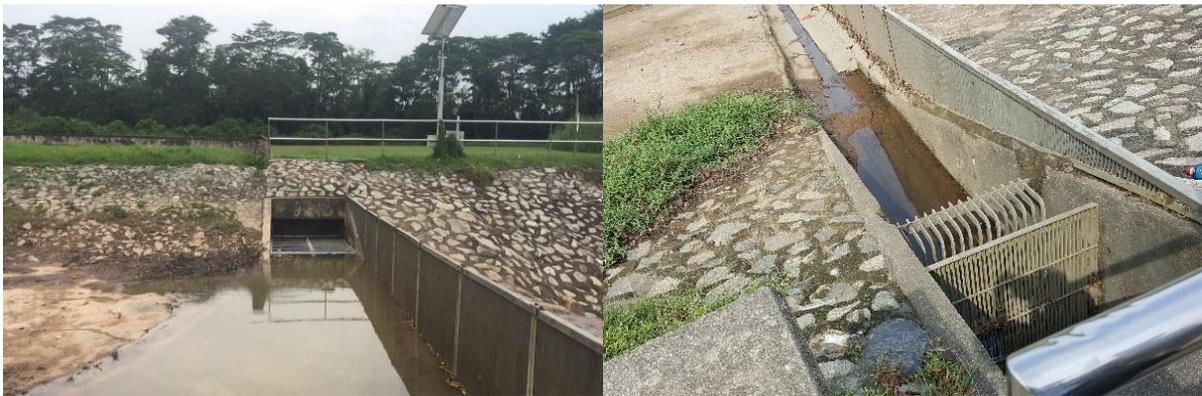
Figs. 8. A filtration system at the start of drain channels into the mangrove area.

In addition, a biweekly maintenance cleansing regime to remove the flotsam, trash, and litter from the stream was executed to ensure that the stream was minimally impacted in the long run. A filtration system was installed at the start of open concrete drain outlet to limit the amount of rubbish getting into the stream (Fig. 8). Public Utilities Board (PUB) also stepped up its cleansing regime in removing the flotsam from the storm water ponds next to the mangrove patch especially during the monsoon season.

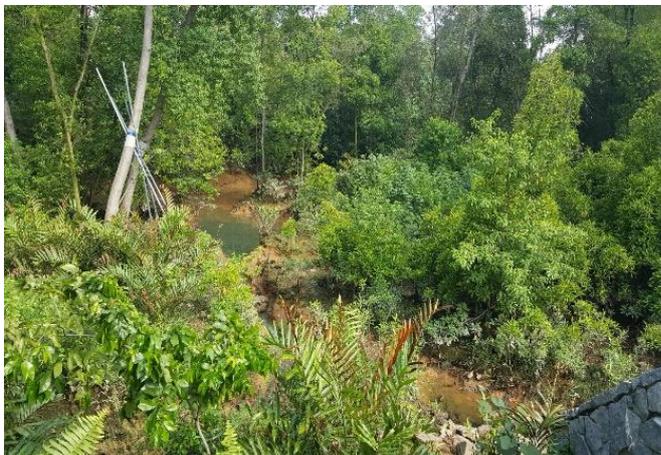
Fig. 9. Back mangrove saplings along the creek.

The common and easy-thriving mangrove plants had been reintroduced mainly in the habitat enhancement of the mangrove site. The planting of 10% dominant species, namely *Avicennia* spp., *Sonneratia* spp., *Rhizophora* spp., and *Bruguiera* spp., would facilitate the restoration of the mangrove habitat (Fig. 9). The heavy Sea Hibiscus vegetation along the mangrove creek next to the park side had also been removed and those located opposite the park had been pruned to make head room for the new mangrove saplings to nurture and become established at site. Fallen branches were regularly removed so that these saplings could thrive in the long run.

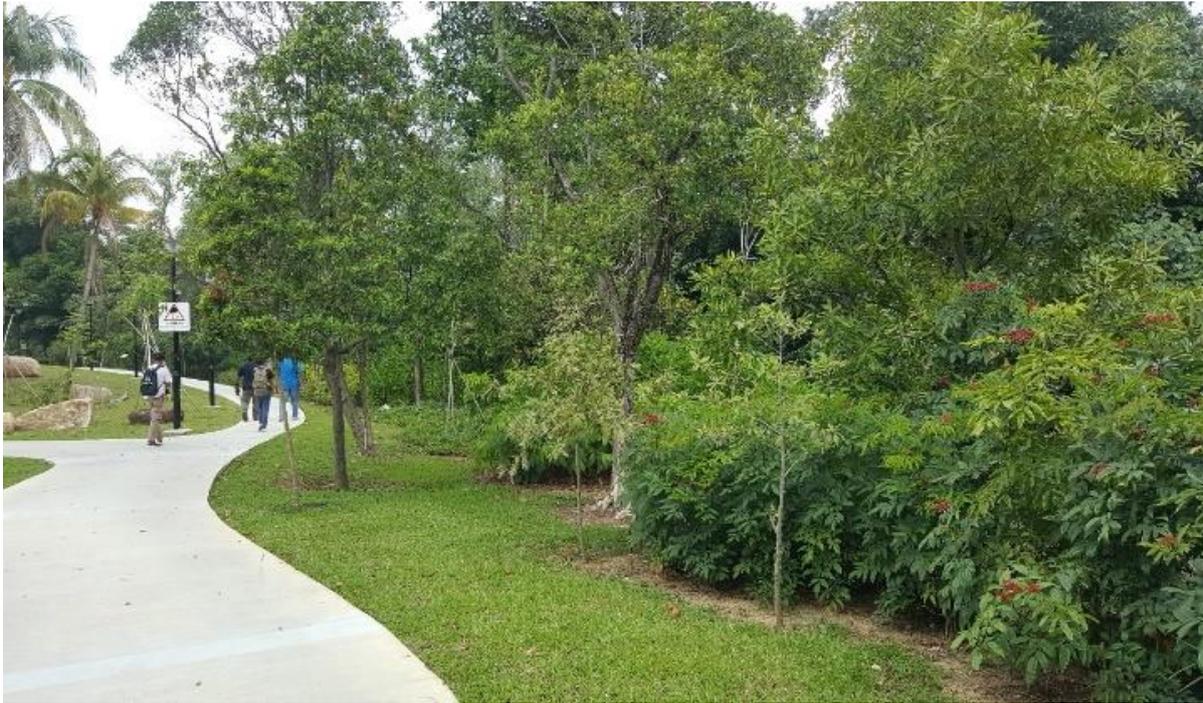
Fig. 10. Plant species adapted to the edges of the creek.

Furthermore, the back mangrove area had been enhanced with plant species that could do well in a low density of brackish water. These plants include Cannonball Mangrove (*Xylocarpus granatum*), Katong Laut (*Cynometra ramiflora*), Mangrove Palm (*Nypba fruticans*), False Lime (*Suregada multiflora*), and White Samet (*Melaleuca cajaputi*). Species such as *Neolitsea zelaynica*, Penaga Laut (*Calophyllum inophyllum*), Chengal Pasir (*Hopea odorata*), and Thick-Leafed Jambu (*Syzygium pachyphyllum*) that adapted to the landward edge of the mangroves were also planted along the periphery to create a natural buffer between the mangrove forest and the park (Fig. 10).
