## A Case for Ecological Planning

# Urban Flooding in Old and New Jakarta

Text by Christopher Silver  
Images as credited

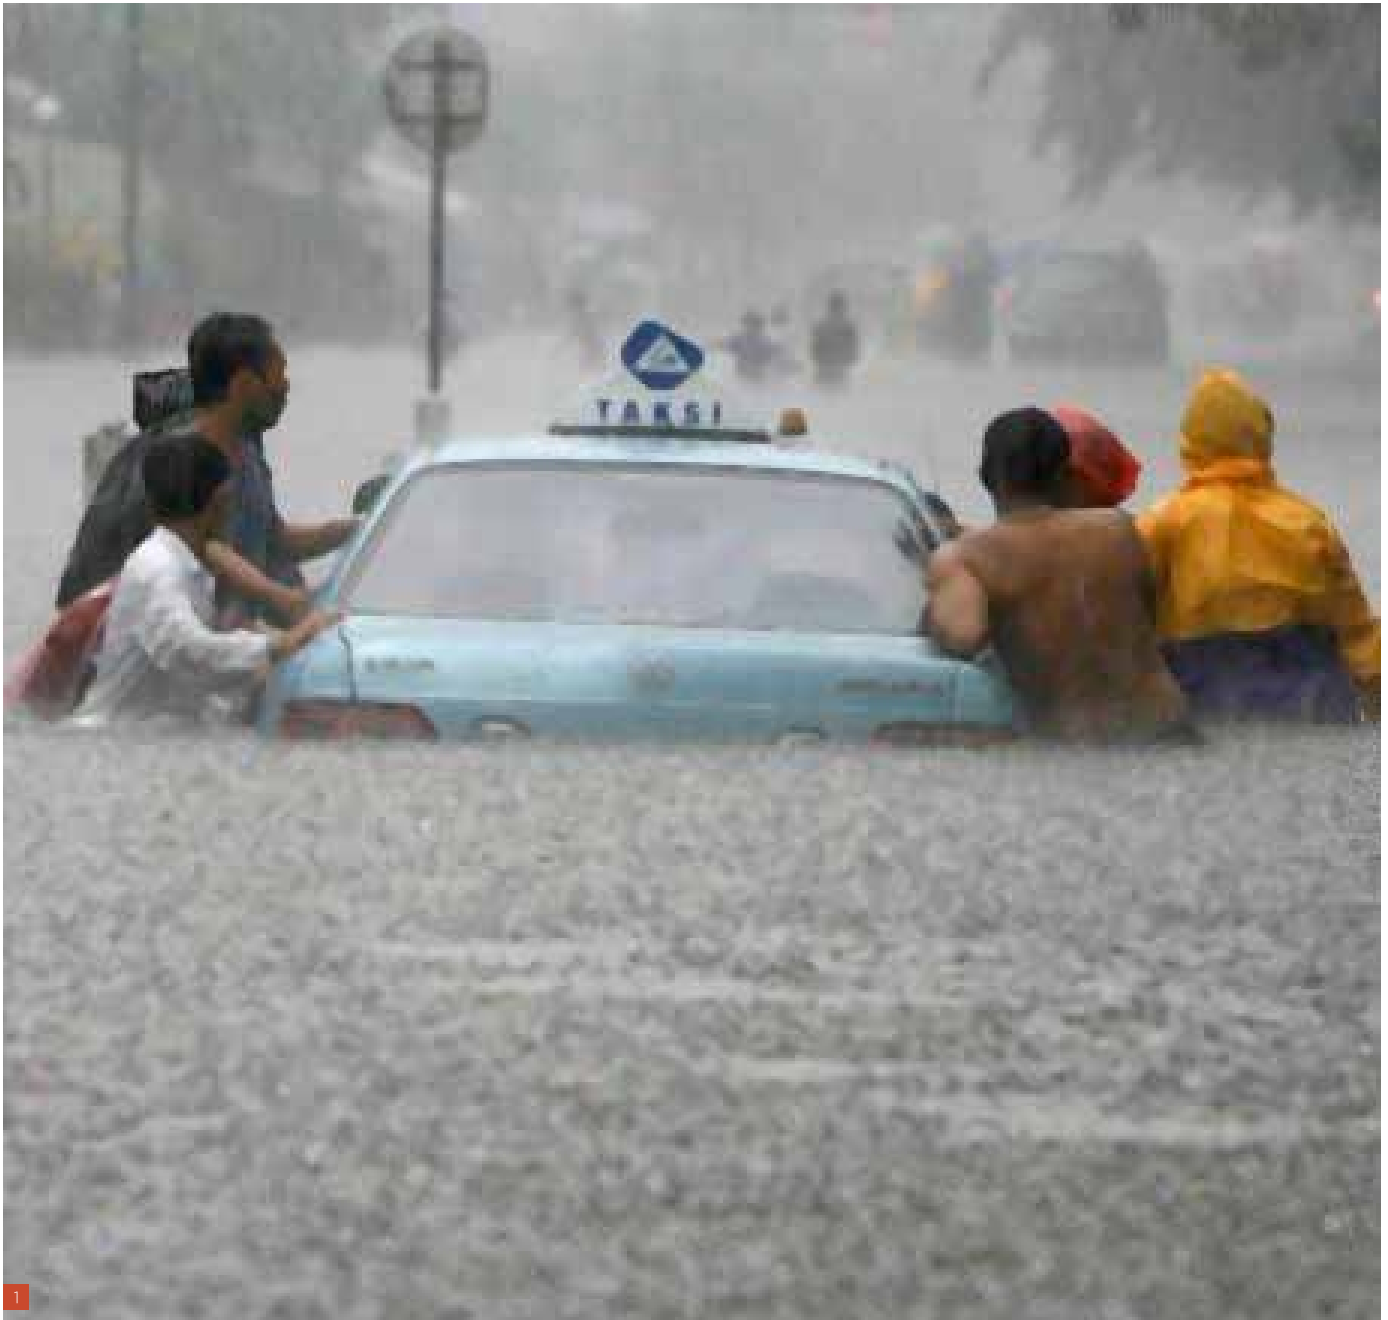
1. The 2011 flood in Jakarta represented the fifth major flood in the city since 2002 (Photo: Google).

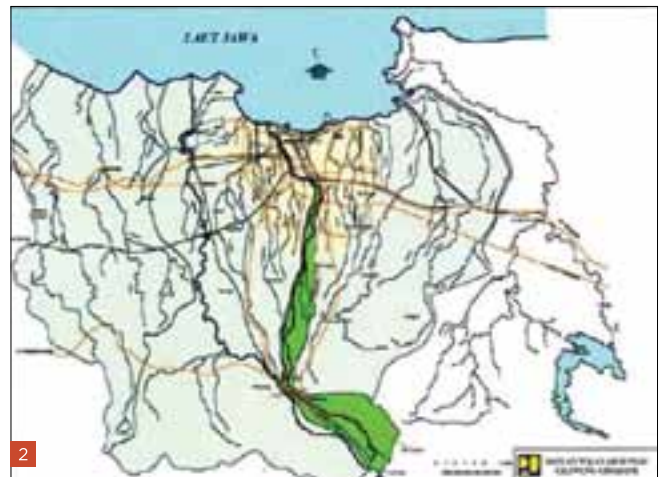
2. Thirteen rivers and their tributaries feed through the urbanised area of Jakarta. At the centre, and highlighted, are the Ciliwung-Cidare rivers, which historically have been a major waterway (Image: Ministry of Public Works, Jakarta, Indonesia).

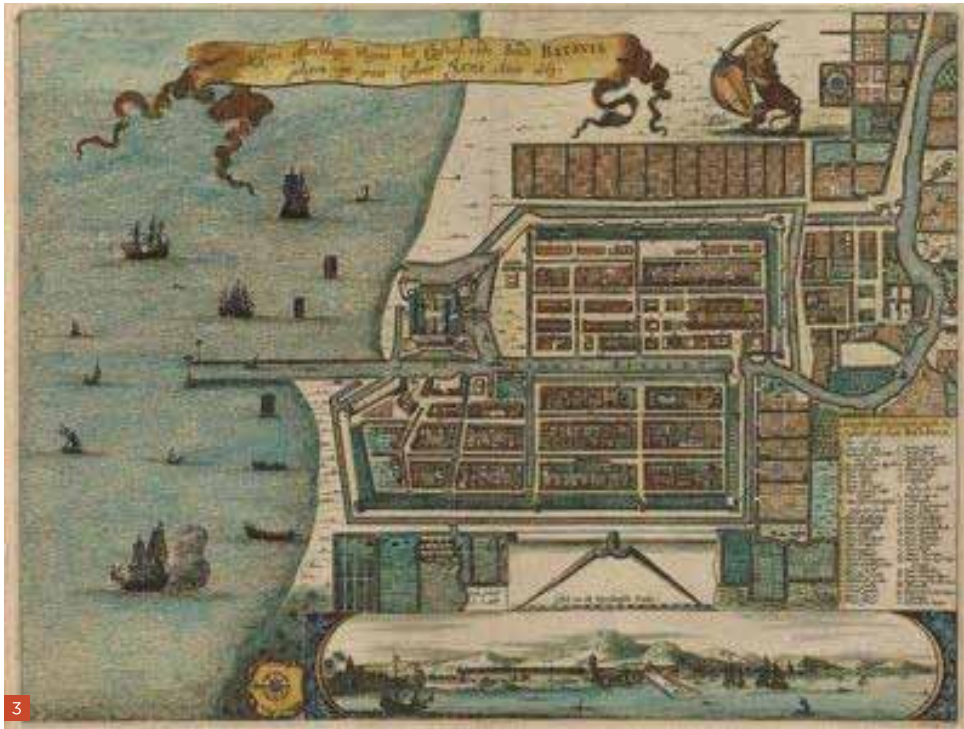
3. In colonial Batavia, a system of canals served the compact settlement its transportation needs and as the major source of water for urban activities (Image: Princeton University Library, libweb5.princeton.edu).

The explanation to both of these observations can be discerned in the evolving form and scale of urbanisation over the past four centuries. Batavia began as a compact city where the nearby rivers, especially Ciliwung, had been harnessed in an engineered system of canals. Fed by the rivers, this canal system provided the major transportation network as well as the primary source of water to support urban life. Frequent dredging through tremendous human exertion was necessary to keep these waterways in a navigable condition, to prevent flooding during the rainy season and to ensure sufficient water resources during the dry season. Much of the watershed was harnessed for the agricultural production in Batavia's hinterland through a series of irrigation canals, and this was often a factor in the inadequate supply of water for the urbanised area during the dry season. As the settlement of Batavia expanded southward from its compact fortified enclave in the early-nineteenth century, this precipitated changes in the water management approach. These newly settled areas occupied higher ground and relied more on land-based transport than did the original settlement along the northern coast. There was only a partial extension of the canal system to serve the new suburbs, which were known as Weltevreden. With a growing population needing potable water, there was a shifting reliance from surface to ground water to meet those needs. A modernised transportation system, including the railroad and trolley

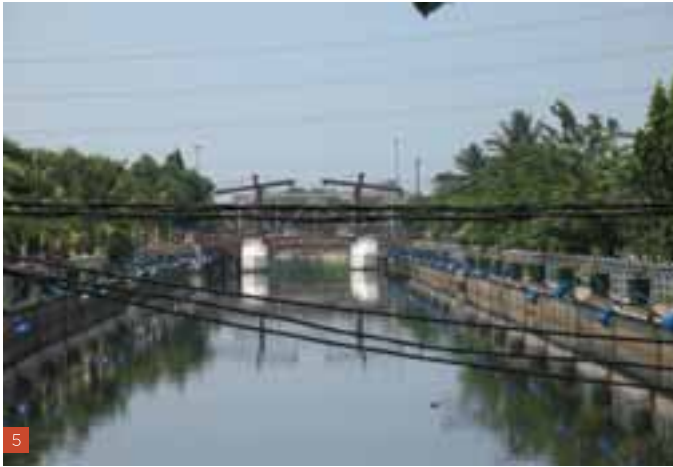
5. By the early-twentieth century, the canals remained more for their aesthetic value than functional importance, and this led to reduced emphasis on needed maintenance (Photo: Christopher Silver).

lines, coupled with construction of a new shipping port east of the city, led to the reduced maintenance of the original canal system. In several places, canals were filled in to support the new surface roadways. In 1918, the expanded European settlement in a planned community in Weltevreden, known as Menteng, was hit with the worst flooding since the mid-nineteenth century. To protect this developing area, the city engineer devised a plan for a system of flood canals to ring the existing urbanised areas and to tie several of the major rivers that flowed in Batavia. The van Breen plan for the flood canal system began in the early 1920s and was only partially completed by 1942 when World War II and the subsequent occupation by the Japanese military interrupted its construction. After the independence of Indonesia in 1950, no additional work occurred on this project for more than half a century. The unbuilt eastern portion of the flood canal was not started until the devastating floods of recent years.

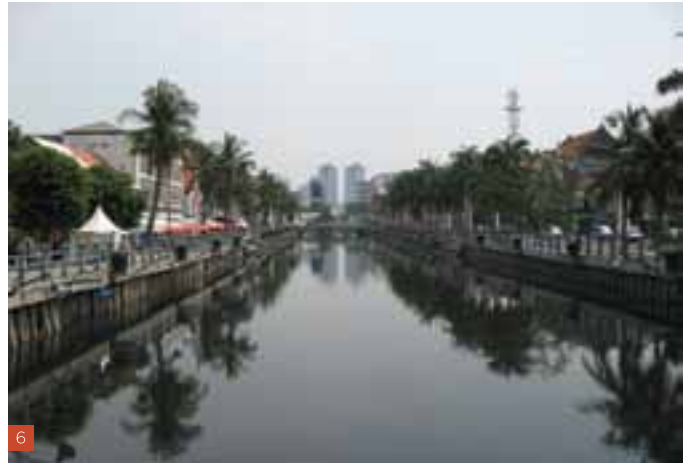
6. The Kali Besar (Grand River) is one of the few remaining pieces of the original city canal system in Jakarta. Only a small part of it remains in Jakarta today and holds stagnant water (Photo: Christopher Silver).

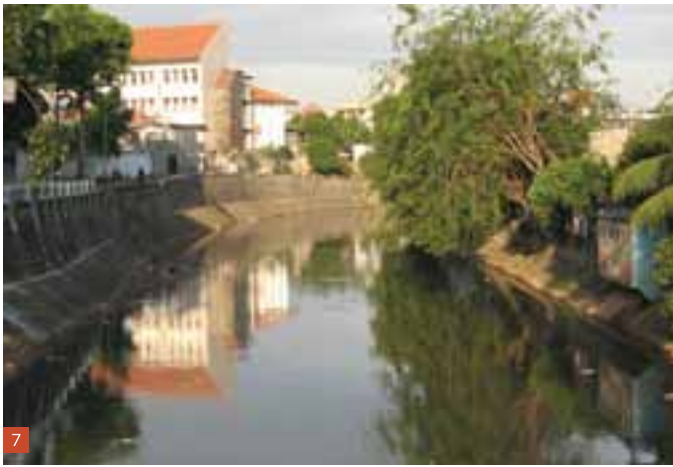
7. Ciliwung River in central Jakarta has been reduced in width and depth as urbanisation has spread over its natural course (Photo: Christopher Silver).

Fast-forwarding to the 1990s, over the previous four decades since independence in 1950, Jakarta's urbanisation had pushed development across the entire watershed, with little or no integration with the river system. In the case of the Ciliwung River, which traditionally had been the most navigable waterway and which typically handled the largest volume of rainfall, its capacity had been reduced appreciably. Having once spanned nearly 150 metres at its widest, it had in recent years become little more than a modest drainage canal, no greater than 30 metres in width and unable to supply either potable water or suitable protection from excessive rainfall. The encroachment of both planned and unplanned development into the city's river network reduced its capacity to handle storm waters appreciably and added to the debris that kept them permanently clogged and polluted. The flood canal network designed in the 1920s had been sufficient to protect the urbanised area within its boundaries but had no effect on those areas beyond its reach, as urban development expanded deeply in the hinterland and across the entire watershed. And because the eastern portion of the flood canal was not completed until recently, the entire eastern side of Jakarta routinely sustained some of the worst effects of flooding during the rainy season. The completion of the East Flood Canal became a top priority in the wake of the devastating 2007 flood. However, in the context of the overall problems of storm water management in Jakarta, it was at best a partial remedy. As Trisakti University hydrologist Irwin Iskandar noted, the flood canal system, devised by the Dutch in the 1920s and recently completed with the addition of the East Flood Canal, was appropriate when the city spanned an area of 2,500 hectares. Since the Jakarta megacity now encompasses 65,000 hectares, the existing flood canal system only protected less than five percent of the urbanised area. When the 2007 flood swept over much of the city, beyond the inner ring supported by the historic flood canal network, it was evident that a different approach to storm water management was needed.

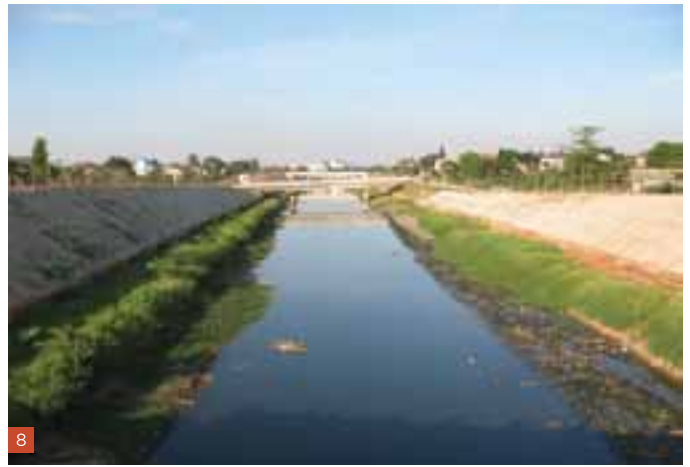
8. The newly completed East Flood Canal completes the original flood canal system designed in the van Breen plan of the early 1920s (Photo: Christopher Silver).

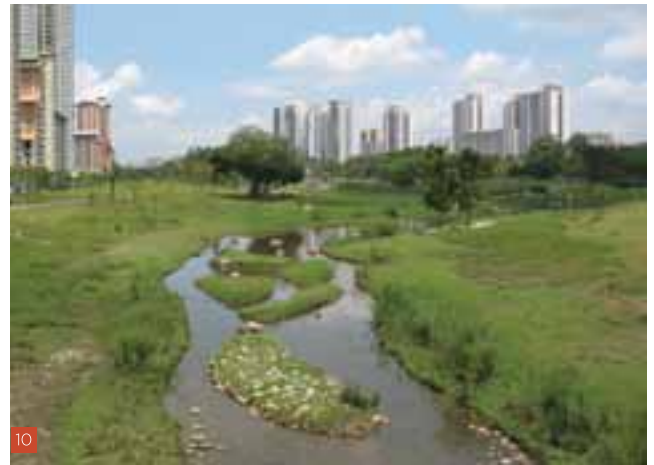
10. This flood management initiative for the Kallang River in Singapore's Bishan Park represents an effort to restore the natural ecology of urban areas and allow rivers to follow their own course (Photo: Christopher Silver).
