Improving Water Quality in Tropical Urban Ponds: A Case Study in East Coast Park

This RTN aims to guide landscape managers on how parks and green spaces can be managed to improve the water quality of ponds in their catchments. It estimates the contributions of major pollutant pathways observed in the catchment of a pond in East Coast Park, and discusses appropriate management strategies to restore and maintain good water quality.

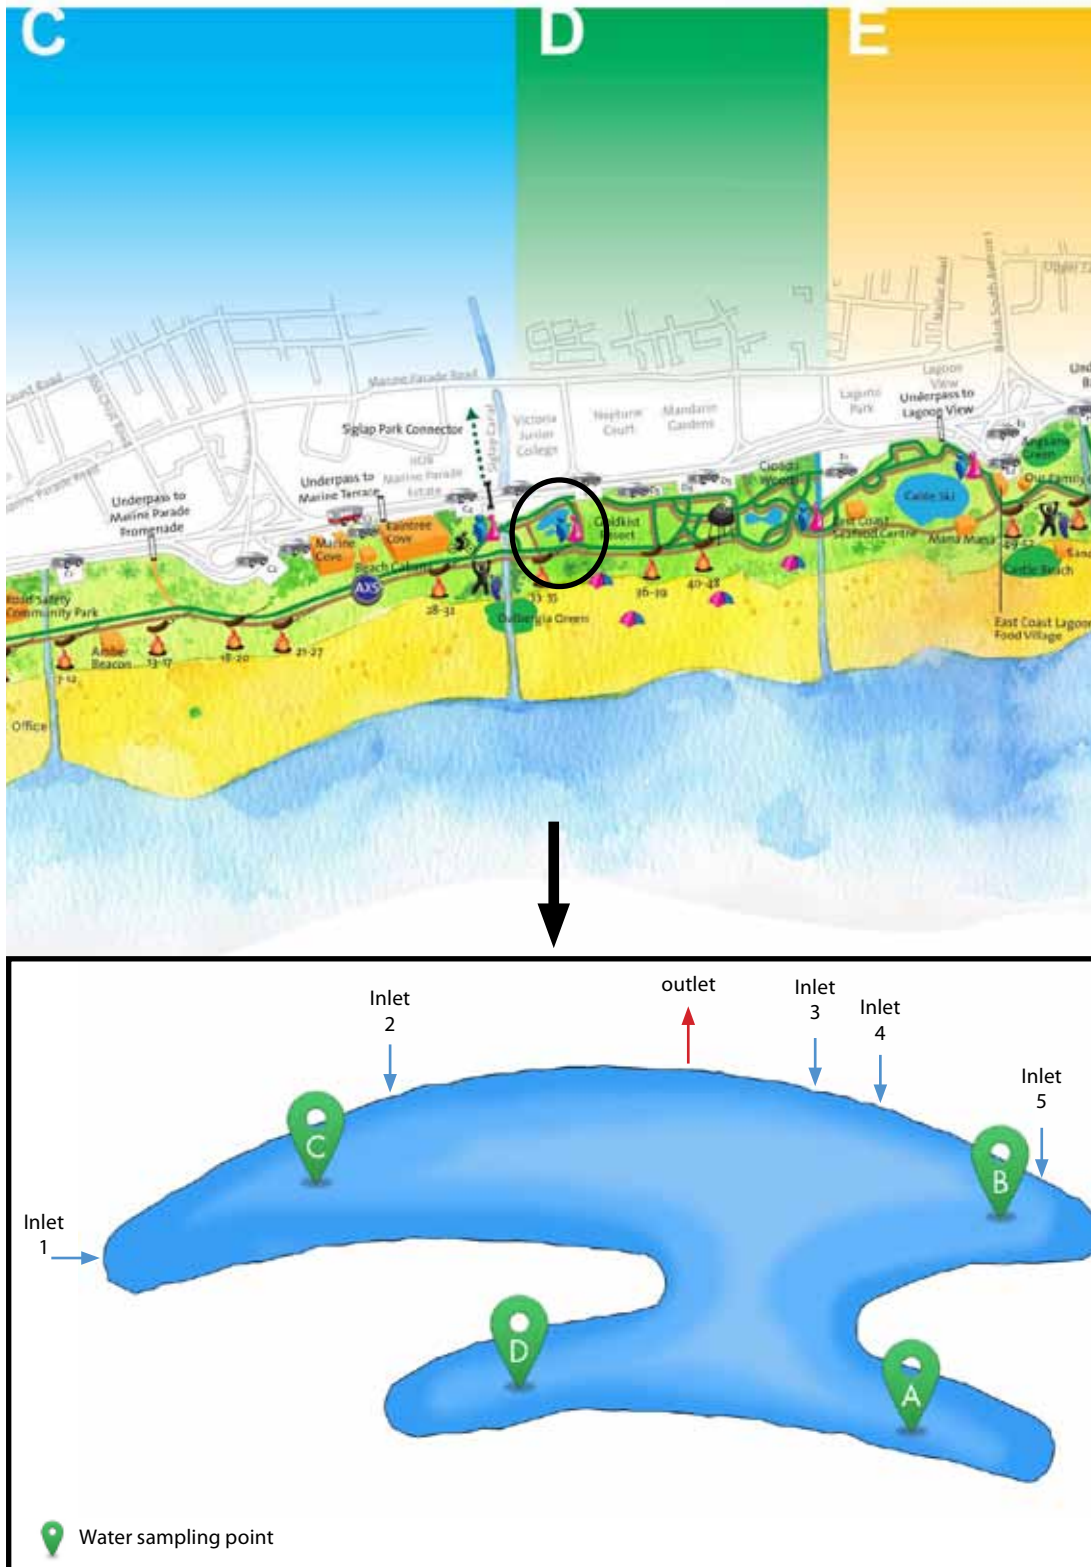
Fig 1. Schematic map of Pond D1, showing locations of inlets, outlets and water sampling points.

The study site was a pond located at East Coast Park Area D1, Singapore. The pond is at least 30 years old, with a concrete base and sides, and a rubble wall embankment. Its depth varies from 0.5m in a perimeter ledge, to 2.3m in the central regions. The pond drains a catchment of 0.4 hectares with five inlets along its northern perimeter, and outlets which drain the pond at a fixed height of 0.3m below the top of the embankment. It is divided into four sections which taper towards their extremities, yielding the shape of an exaggerated hourglass (Fig 1).

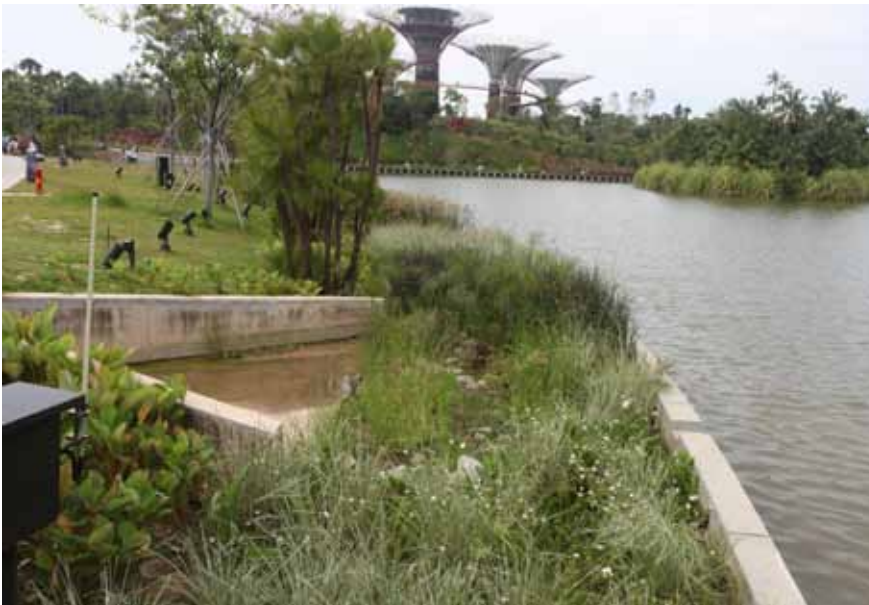
Fig 2. Vegetated filter bed, Bay South, Gardens By the Bay. Note that runoff is detained in the filter bed to allow nutrient uptake by plants.
(Credit: Benjamin Loh)

The estimates of external nutrient loads ([Table 1](#)) suggest that a combination of strategies is necessary to manage the rate of eutrophication. Firstly, to reduce the entry of dissolved nutrients into the pond via the inlets, the inlets can be diverted to filter beds containing plants selected for rapid nutrient uptake, such as Water Hyacinth (*Eichhornia crassipes*), Dwarf Papyrus (*Cyperus haspan*) and Water Lettuce (*Pistia stratiotes*) ([Fig 2](#)). Further, in order to reduce the incidence of grass clippings and leaves blowing into the pond, a vegetated filter strip can be established around the pond perimeter ([Fig 3](#)). This could trap excess plant material from entering the pond.

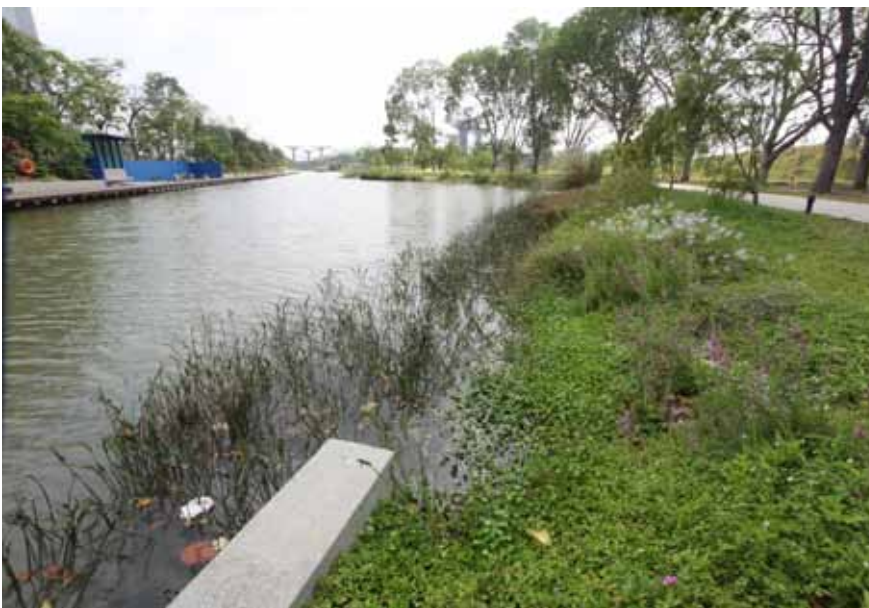
Fig 3. Vegetated filter strip, Bay South, Gardens By the Bay. Note that taller, denser, shrub cover would be necessary to trap excess leaves or grass from blowing into the water body.
(Credit: Benjamin Loh)

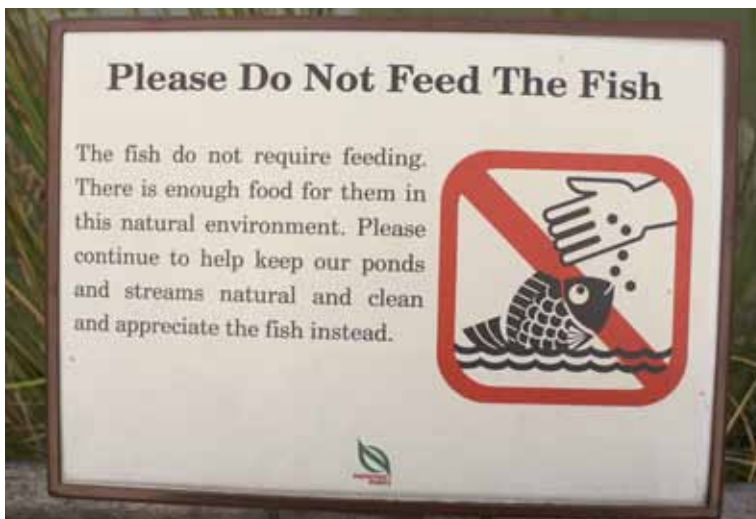
Fig 4. Signage at Dairy Farm Quarry. Public education about the negative ecological impacts of fish-feeding in ponds should be clearly articulated.

The control of activities such as release of aquatic animals and fish feeding at the pond will also be necessary, given that these contribute a significant proportion of the total nutrient load. Besides up-scaling public education efforts (**Fig 4**), one other solution could be to partition one side of the pond apart with a physical embankment, to be dedicated as a fish feeding area. This would divert the nutrient loads associated with these activities into a smaller, more manageable area, whilst continuing to meet the recreational needs of the public.

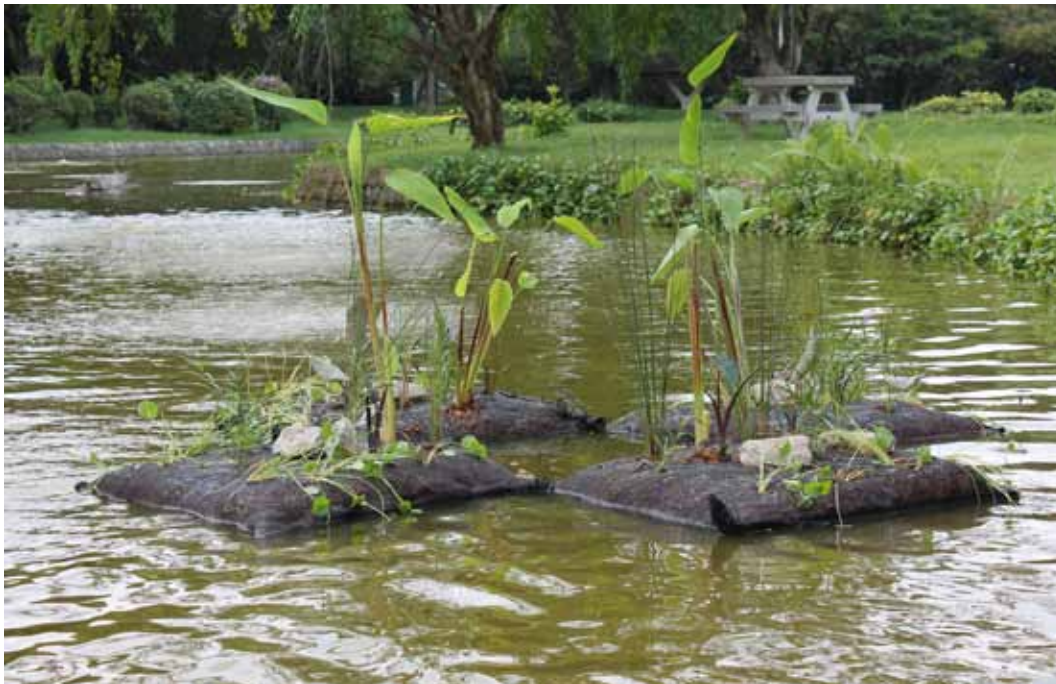
Fig 5. Floating Wetlands, West Coast Park Pond. To avoid trapping surface debris and contributing to water stagnancy, floating wetlands should be anchored securely some distance from the pond edge. For floating wetlands to improve water quality, it is important to remove plant biomass periodically.

In the case of East Coast Park Pond D1, the nutrient accumulation has been found to be so severe as to warrant a complete reset of the system through dredging. Whilst dredging can be costly, if nutrients already inside the pond are not removed first, any measures to improve long term water quality by reducing external loads are unlikely to be successful. To reduce the frequency of subsequent dredging required, macrophytes should be established in the pond after the dredging operation has taken place, for example inside the shallower pond perimeter zones, or in floating wetlands (Fig 5) or as floating water plants in contained areas (Fig 6). This would allow nutrients to be removed from the pond by the plants when they are pruned periodically to remove biomass.

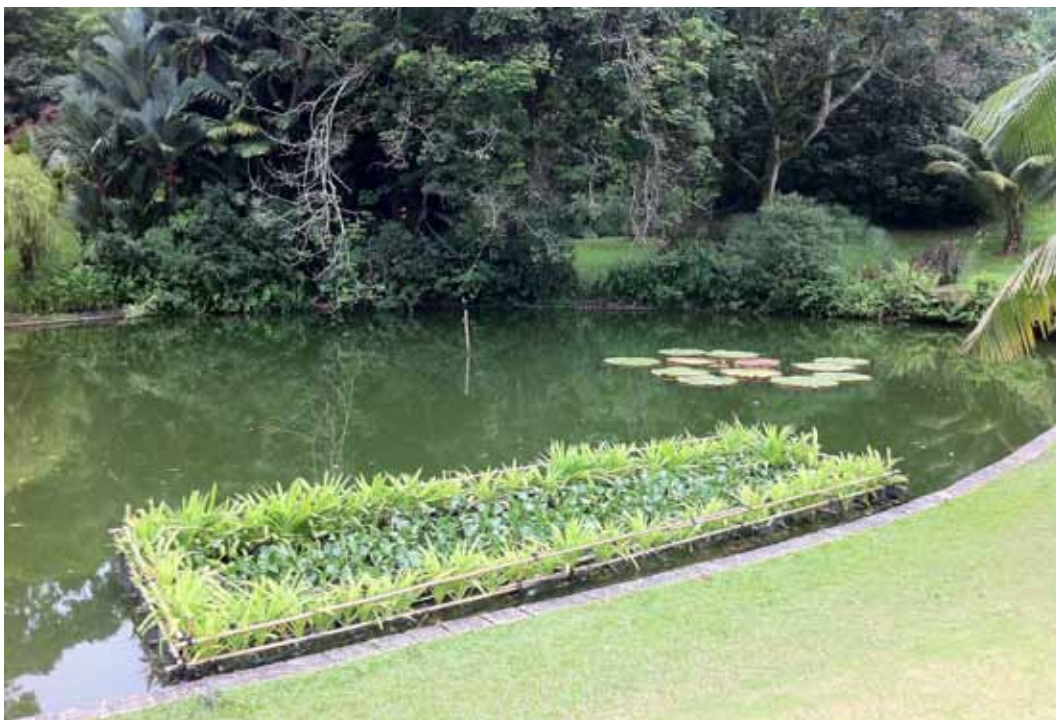
Fig 6. Floating water plants (Water Hyacinth) planted in a contained area, Istana Swan Pond. As for floating wetlands, it is important to remove plants periodically in order to remove nutrients from the pond.
